Flood Control Project Maintenance
2015 Structure Summary Report
Overall Unit and Item Ratings

DWR Sutter Maintenance Yard

Butte Slough Drainage Structure

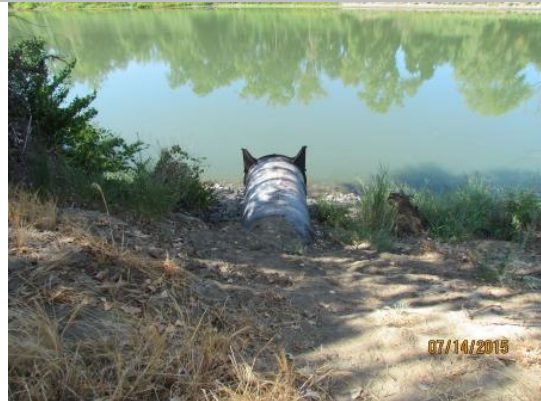
Photo 1 of 5 : ST_2015_NA0060_38_1_20150715_00005.jpg

Butte Slough Drainage structure on the water side.

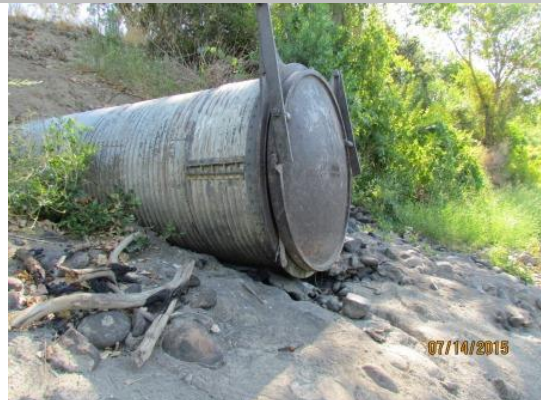
Photo 2 of 5 : ST_2015_NA0060_38_1_20150715_00006.jpg

Butte Slough Drainage structure outfall.

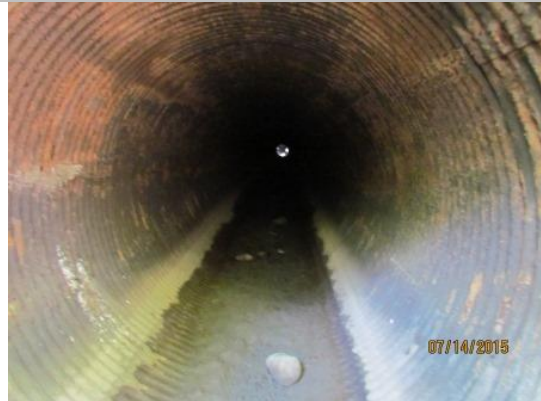
Photo 4 of 5 : ST_2015_NA0060_38_1_20150715_00008.jpg

View of the pipe from the landside.

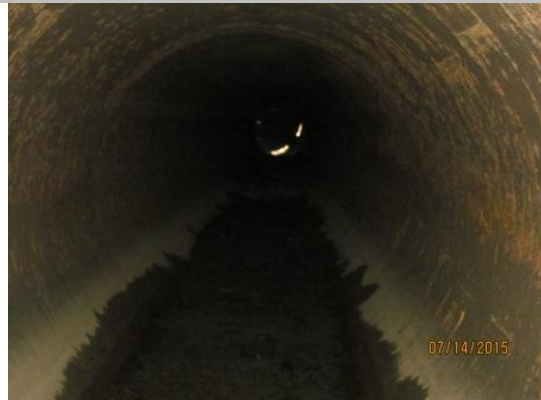
Photo 5 of 5 : ST_2015_NA0060_38_1_20150715_00009.jpg

Zoomed-in view of the pipe from the landside.

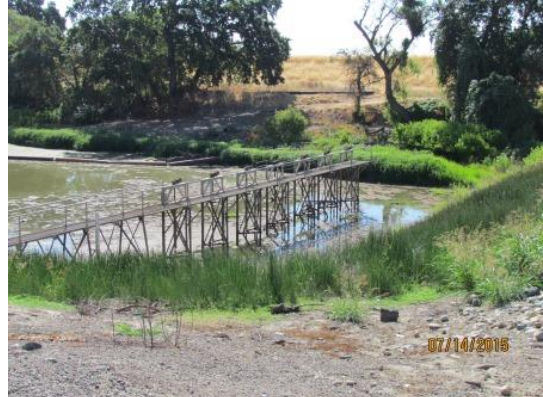
Photo 1 of 4 : ST_2015_NA0060_42_1_20150715_00005.jpg

View of the Butte Slough Outfall Structure on the land side.

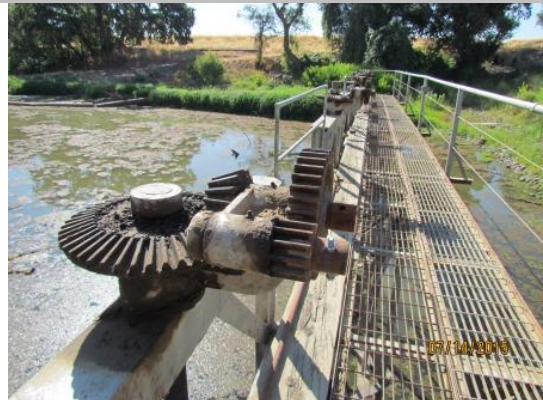
Photo 2 of 4 : ST_2015_NA0060_42_1_20150715_00006.jpg

View of the mechanical gate operation mechanism.

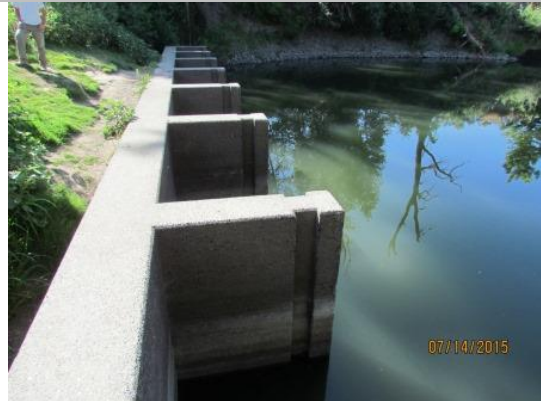
Photo 4 of 4 : ST_2015_NA0060_42_1_20150715_00008.jpg

View of the Butte Slough Outfall Structure on the water side.

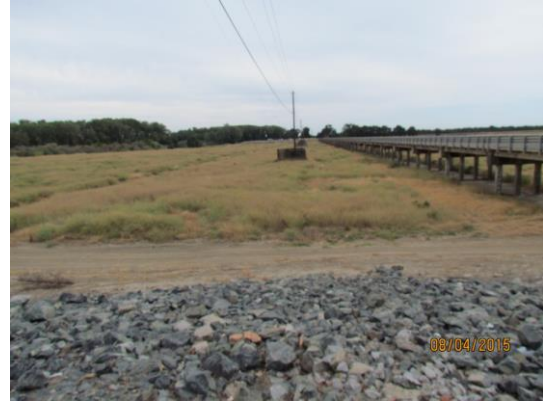
Photo 1 of 6 : ST_2015_NA0060_55_1_20150810_00005.jpg

View of the weir from the right bank.

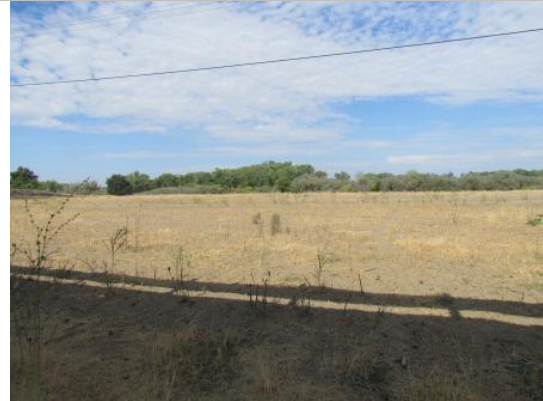
Photo 2 of 6 : ST_2015_NA0060_55_1_20150528_00002.jpg

This is the upstream view of the Colusa Weir structure.

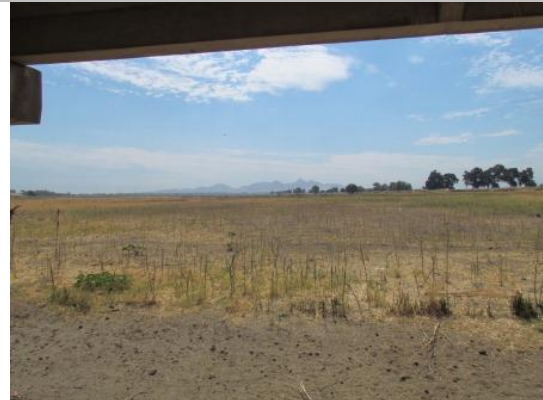
Photo 3 of 6 : ST_2015_NA0060_55_1_20150528_00003.jpg

This is the downstream view of the Colusa Weir structure.

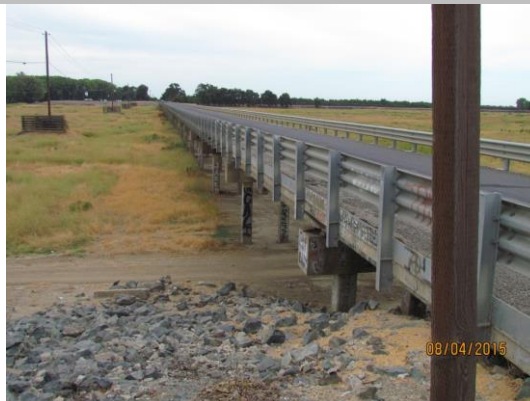
Photo 4 of 6 : ST_2015_NA0060_55_1_20150810_00007.jpg

View of the weir from the right bank.

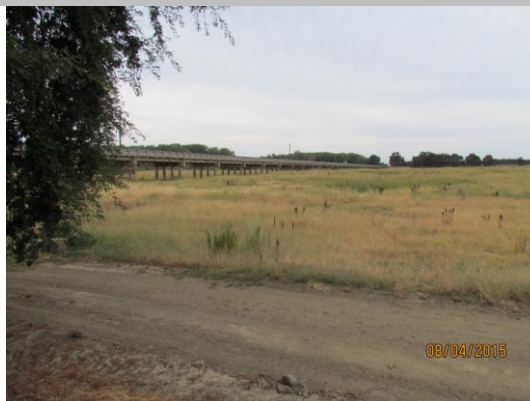
Photo 5 of 6 : ST_2015_NA0060_55_1_20150810_00010.jpg

View of the weir facing upstream from the right bank.

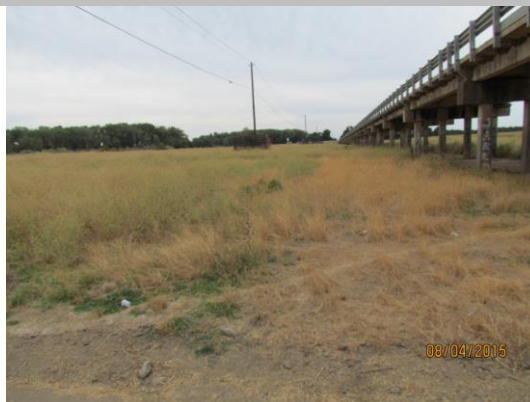
Photo 6 of 6 : ST_2015_NA0060_55_1_20150810_00011.jpg

View of the weir from inside the right bank of the channel.

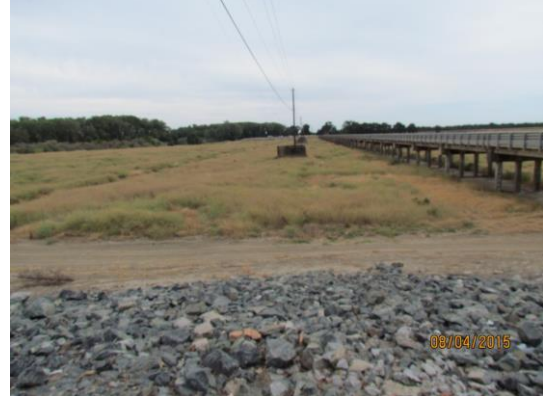
Photo 1 of 2 : x_2015_NA0060_55_5_20150820_00012.jpg

LM Start	0.00	Rating **	A	Issue No.	5
LM End	0.00	Issue Type +	Ma	Location *	
Category	Structures & Concrete Lined Channels			GPS Latitude/Longitude	
				Start	End
Item	Revetments			39.232135 °	39.232135 °
				-121.996253 °	-121.996253 °
DWR ID	DWR_NA0060_55_t_2012_5				
Action/Comments					
Inspector Comments: Existing riprap protection is properly maintained and is undamaged. Riprap clearly visible.

View of the weir and the riprap.

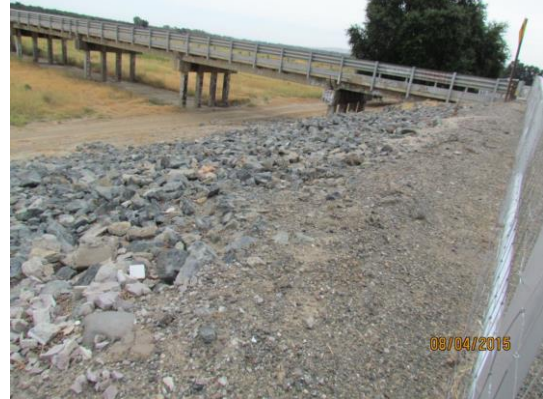
Photo 2 of 2 : x_2015_NA0060_55_5_20150820_00013.jpg

View of the wier and the riprap facing downstream.

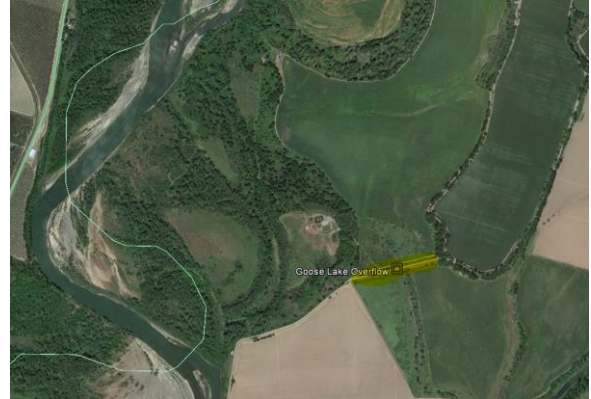
Photo 1 of 1 : ST_2015_NA0060_225_1_20150827_00005.jpg

The structure location is highlighted and is shown in relation to the Sacramento River.

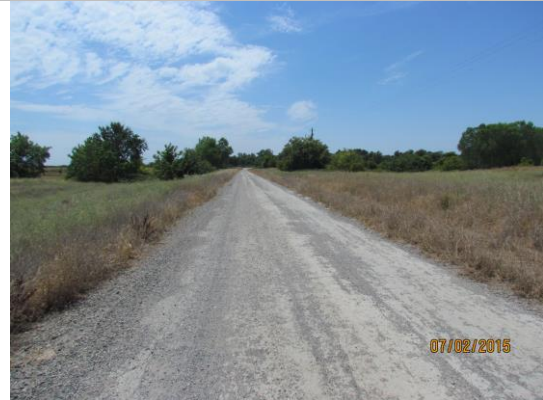
Photo 1 of 1 : ST_2015_NA0060_225_2_20150728_00003.jpg

View of the vegetation on both slopes of the weir.

LM Start	0.00	Rating **	M	Issue No.	2
LM End	0.00	Issue Type +	Ma	Location *	LS
Category	Structures & Concrete Lined Channels			GPS Latitude/Longitude	
				Start	End
Item	Vegetation & Obstructions			39.569247 °	39.569247 °
				-121.982569 °	-121.982569 °
DWR ID	DWR_NA0060_225_t_2013_2				
Action/Comments					
Inspector Comments: Spray the vegetation for approximately 100 feet on both sides of the weir.

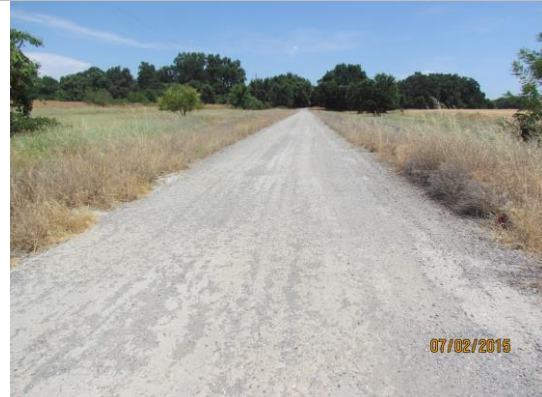
Photo 1 of 1 : ST_2015_NA0060_225_15_20150728_00004.jpg

View of the concrete crown roadway on the top of the weir.

LM Start	0.00	Rating **	A	Issue No.	15
LM End	0.00	Issue Type +	Ma	Location *	LS
Category	Structures & Concrete Lined Channels			GPS Latitude/Longitude	
				Start	End
Item	Concrete Surfaces			39.569248 °	39.569248 °
				-121.982569 °	-121.982569 °
DWR ID	DWR_NA0060_225_t_2013_15				
Action/Comments					
Inspector Comments: Farm equipment needs to stay off of the weir to prevent further damage to the concrete surface.

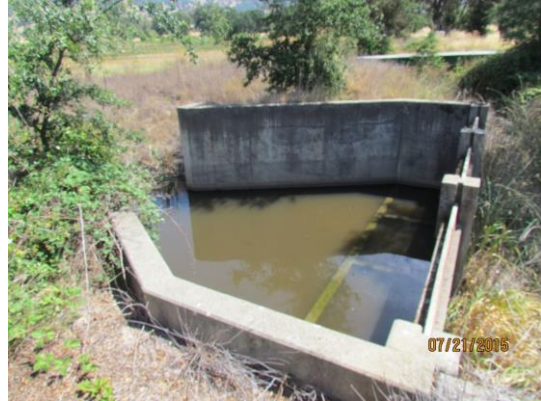
Photo 1 of 2 : ST_2015_NA0060_7_1_20150807_00012.jpg

View of the weir.

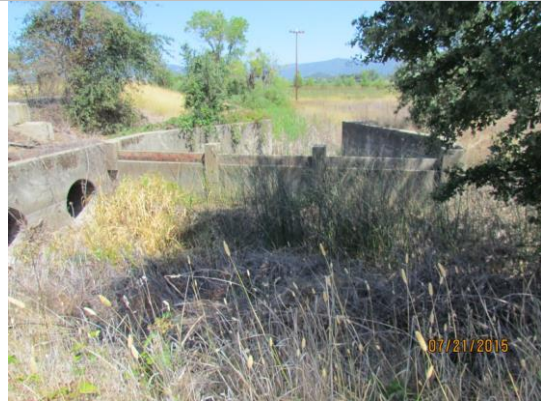
Photo 2 of 2 : ST_2015_NA0060_7_1_20150807_00013.jpg

Alternate view of the weir.

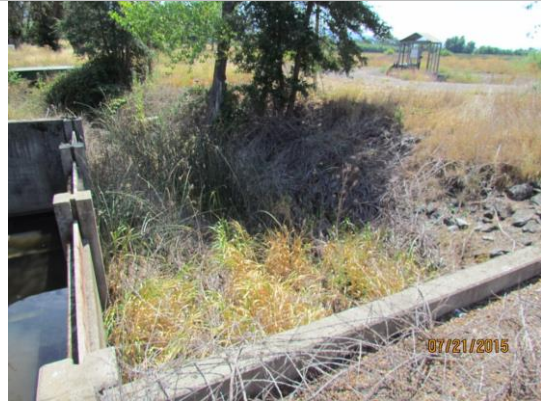
Photo 1 of 2 : ST_2015_NA0060_7_2_20150807_00014.jpg

LM Start	0.00	Rating **	M	Issue No.	2
LM End	0.00	Issue Type +	Ma	Location *	
Category	Structures & Concrete Lined Channels			GPS Latitude/Longitude	
				Start	End
Item	Vegetation & Obstructions			39.126317 °	39.126317 °
				-122.882733 °	-122.882733 °
DWR ID	DWR_NA0009_7_t_2012_2				
Action/Comments					
Inspector Comments: There was vegetation growth such as cat tails and bushes in the structure which might impede the flow of water through the culvert.

View of the vegetation growth on the inlet of the structure.

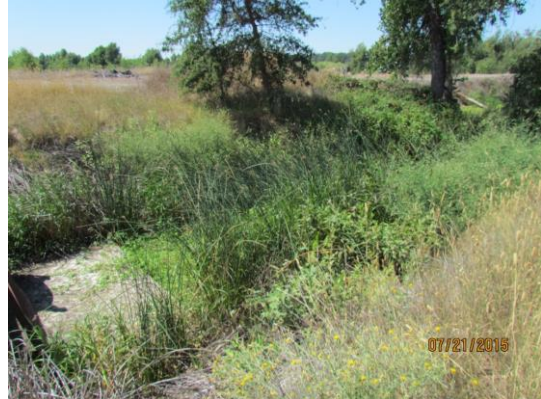
Photo 2 of 2 : ST_2015_NA0060_7_2_20150807_00016.jpg

LM Start	0.00	Rating **	M	Issue No.	2 (cont)	
LM End	0.00	Issue Type +	Ma	Location *		
Category	Structures & Concrete Lined Channels			GPS Latitude/Longitude		
				Start		End
Item	Vegetation & Obstructions			39.126317 °		39.126317 °
				-122.882733 °		-122.882733 °
DWR ID	DWR_NA0009_7_t_2012_2					
Action/Comments						
Inspector Comments: There was vegetation growth such as cat tails and bushes in the structure which might impede the flow of water through the culvert.

View of vegetation on the outlet of the structure.

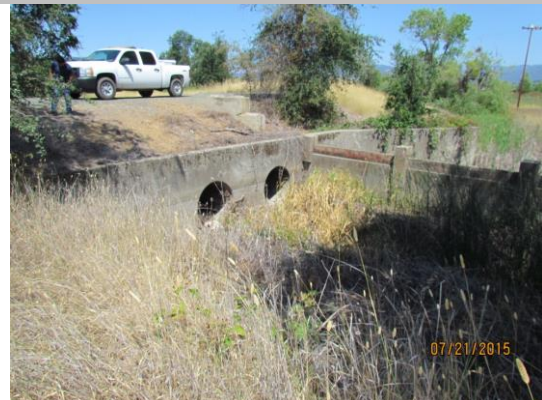
Photo 1 of 2 : ST_2015_NA0060_7_7_20150807_00017.jpg

LM Start	0.00	Rating **	M	Issue No.	7
LM End	0.00	Issue Type +	Ma	Location *	
Category	Structures & Concrete Lined Channels	GPS Latitude/Longitude			
		Start		End	
Item	Culverts: Inlets / Outlets	39.126317 °		39.126317 °	
		-122.882733 °		-122.882733 °	
DWR ID	DWR_NA0009_7_t_2012_7				
Action/Comments					
Inspector Comments: Vegetation was blocking less than 10% of the culverts opening.

View of inlet of the culvert.

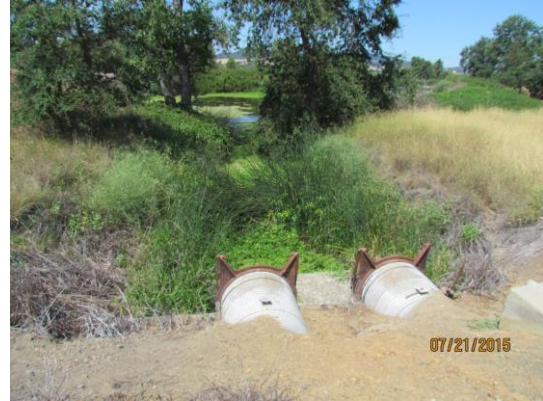
Photo 2 of 2 : ST_2015_NA0060_7_7_20150807_00018.jpg

LM Start	0.00	Rating **	M	Issue No.	7 (cont)
LM End	0.00	Issue Type +	Ma	Location *	
Category	Structures & Concrete Lined Channels			GPS Latitude/Longitude	
				Start	End
Item	Culverts: Inlets / Outlets			39.126317 °	39.126317 °
				-122.882733 °	-122.882733 °
DWR ID	DWR_NA0009_7_t_2012_7				
Action/Comments					
Inspector Comments: Vegetation was blocking less than 10% of the culverts opening.

View of outlet of the structure.

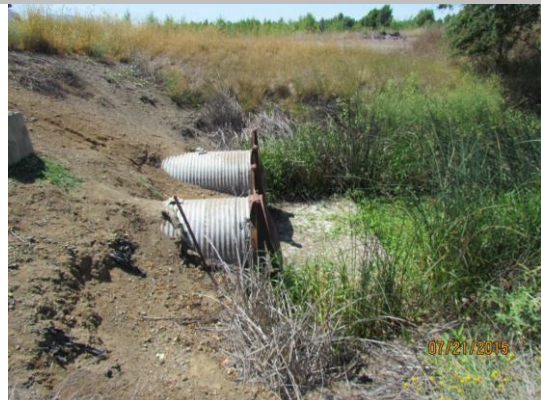
Photo 1 of 1 : ST_2015_NA0060_7_11_20150807_00019.jpg

LM Start	0.00	Rating **	M	Issue No.	11
LM End	0.00	Issue Type +	Ma	Location *	
Category	Structures & Concrete Lined Channels			GPS Latitude/Longitude	
				Start	End
Item	Flap Gates			39.126317 °	39.126317 °
				-122.882733 °	-122.882733 °
DWR ID	DWR_NA0009_7_t_2012_11				
Action/Comments					
Inspector Comments: The flap gates appeared to be in working condition, but one of them was open due to accumulated debris.

View of the flap gates.

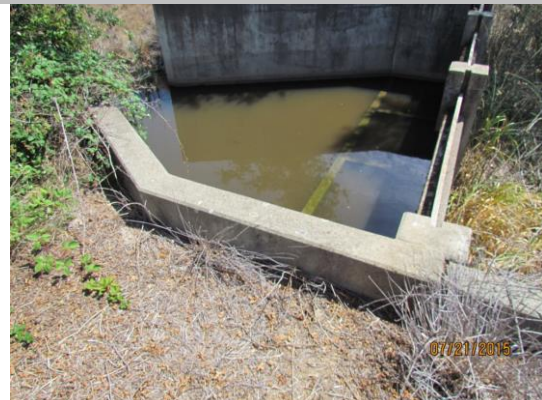
Photo 1 of 1 : ST_2015_NA0060_7_15_20150807_00020.jpg

LM Start	0.00	Rating **	A	Issue No.	15
LM End	0.00	Issue Type +	Ma	Location *	
Category	Structures & Concrete Lined Channels	GPS Latitude/Longitude			
		Start		End	
Item	Concrete Surfaces	39.126317 °		39.126317 °	
		-122.882733 °		-122.882733 °	
DWR ID	DWR_NA0009_7_t_2012_15				
Action/Comments					
Inspector Comments: There was minimal cracking and scaling on the concrete structure, but it didn't appear to threaten the structural integrity.

View of the concrete structure.

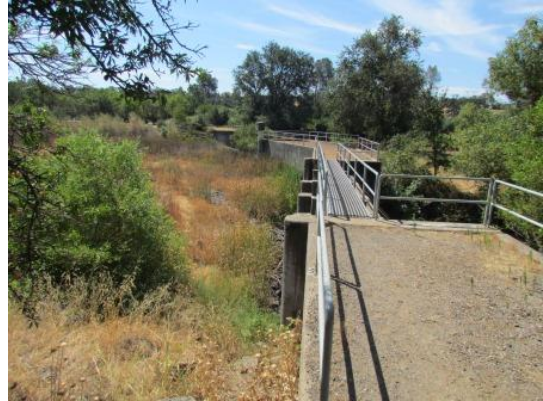
Photo 1 of 5 : ST_2015_NA0060_9_1_20150528_00001.jpg

This is a photo of the control structure.

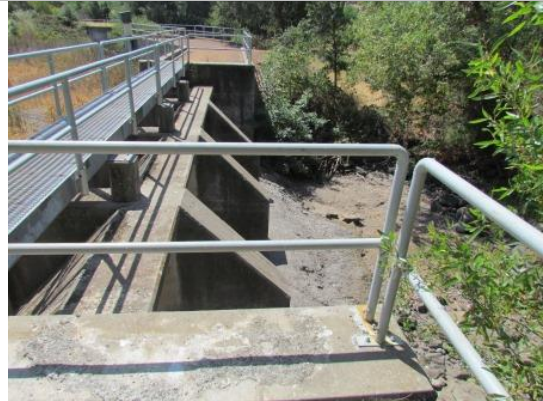
Photo 2 of 5 : ST_2015_NA0060_9_1_20150528_00002.jpg

This is a photo of the downstream side of the control structure.

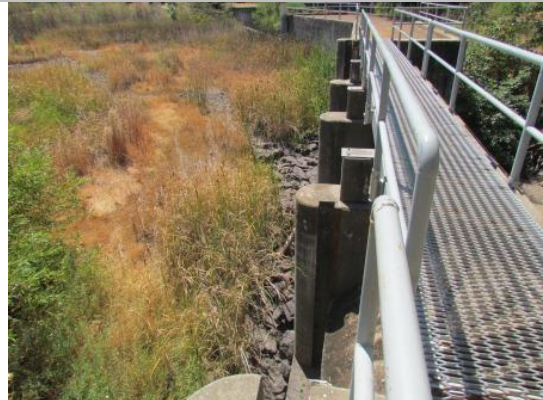
Photo 3 of 5 : ST_2015_NA0060_9_1_20150528_00003.jpg

This is a photo of the upstream side of the control structure.

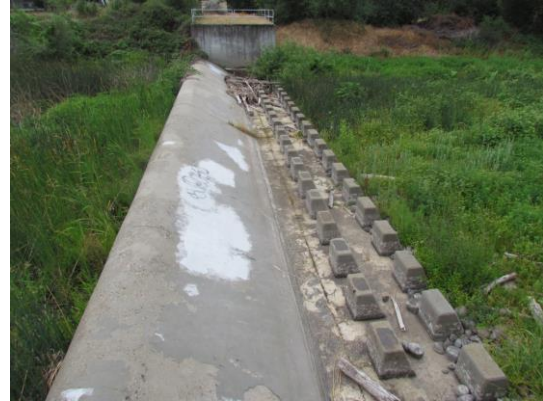
Photo 4 of 5 : ST_2015_NA0060_9_1_20150728_00009.jpg

View of the weir.

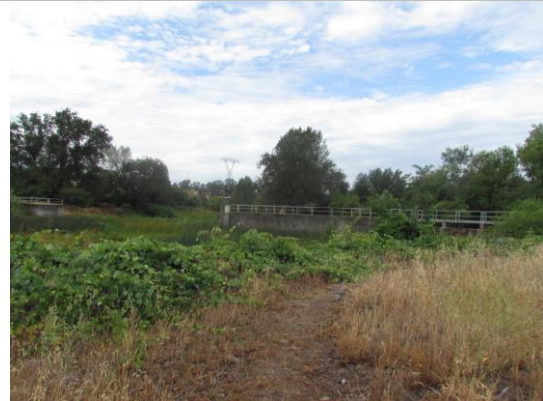
Photo 5 of 5 : ST_2015_NA0060_9_1_20150728_00011.jpg

View of the structure from upstream.

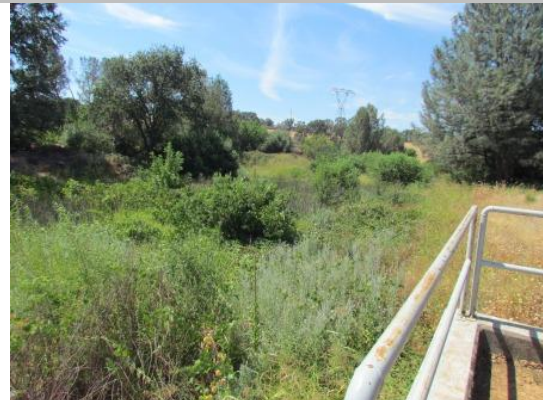
Photo 1 of 2 : ST_2015_NA0060_9_2_20150528_00005.jpg

LM Start	0.00	Rating **	M	Issue No.	2
LM End	0.00	Issue Type +	Ma	Location *	
Category	Structures & Concrete Lined Channels			GPS Latitude/Longitude	
				Start	End
Item	Vegetation & Obstructions			39.733767 °	39.733767 °
				-121.771915 °	-121.771915 °
DWR ID	DWR_NA0060_9_t_2012_2				
Action/Comments					
Inspector Comments: There is some vegetation, a few small trees, and some debris on the weir. The flow may be impeded.

This is a view looking downstream.

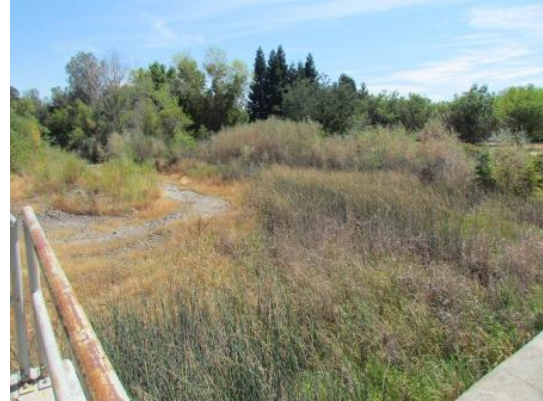
Photo 2 of 2 : ST_2015_NA0060_9_2_20150528_00006.jpg

LM Start	0.00	Rating **	M	Issue No.	2 (cont)	
LM End	0.00	Issue Type +	Ma	Location *		
Category	Structures & Concrete Lined Channels			GPS Latitude/Longitude		
				Start		End
Item	Vegetation & Obstructions			39.733767 °		39.733767 °
				-121.771915 °		-121.771915 °
DWR ID	DWR_NA0060_9_t_2012_2					
Action/Comments						
Inspector Comments: There is some vegetation, a few small trees, and some debris on the weir. The flow may be impeded.

This is a view looking upstream.

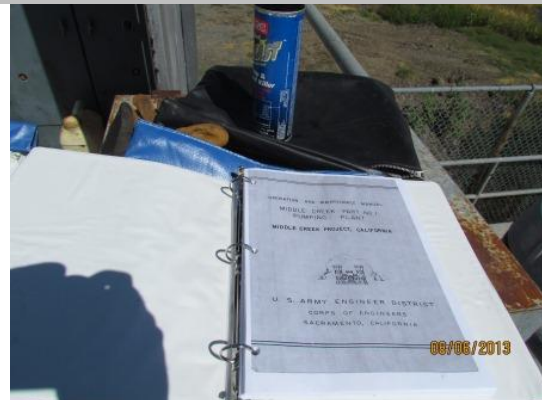
Photo 1 of 1 : ST_2015_NA0060_17_2_20150710_00002.jpg

LM Start	0.00	Rating **	A	Issue No.	2
LM End	0.00	Issue Type +	Ma	Location *	
Category	Pump Stations			GPS Latitude/Longitude	
				Start	End
Item	Operation & Maintenance Manual			39.142300 °	39.142300 °
				-122.902350 °	-122.902350 °
DWR ID	DWR_NA0060_17_t_2012_2				
Action/Comments					
Inspector Comments: The O&M manual was present at the pumping plant.

View of the O&M manual.

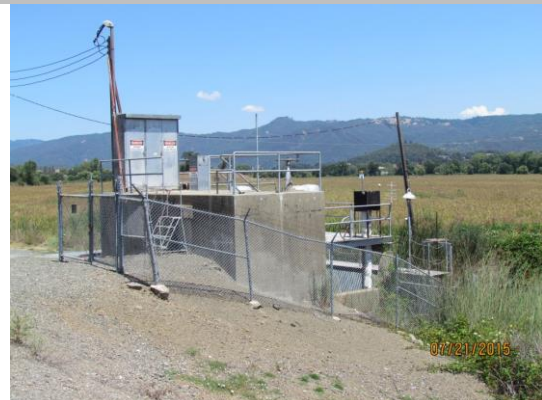
Photo 1 of 2 : ST_2015_NA0060_17_3_20150810_00019.jpg

LM Start	0.00	Rating **	M	Issue No.	3
LM End	0.00	Issue Type +	Ma	Location *	
Category	Pump Stations			GPS Latitude/Longitude	
				Start	End
Item	Plant Building			39.142300 °	39.142300 °
				-122.902350 °	-122.902350 °
DWR ID	DWR_NA0060_17_t_2012_3				
Action/Comments					
Inspector Comments: The plant building was in good structural condition with no major cracks that could threaten the integrity of the building. However, the adjacent structure had some differential settlement.

View of the pumping plant.

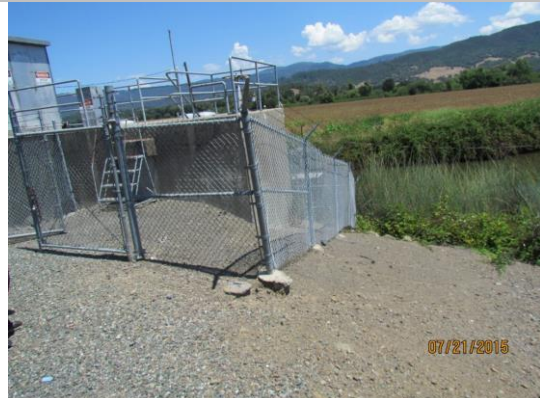
Photo 1 of 1 : ST_2015_NA0060_17_5_20150810_00021.jpg

LM Start	0.00	Rating **	A	Issue No.	5
LM End	0.00	Issue Type +	Ma	Location *	
Category	Pump Stations			GPS Latitude/Longitude	
				Start	End
Item	Safety			39.142300 °	39.142300 °
				-122.902350 °	-122.902350 °
DWR ID	DWR_NA0060_17_t_2012_5				
Action/Comments					
Inspector Comments: No safety hazard was present around the plant. All of the guard rails and fences were secured and in good condition.

View of the security fence and guard rails around the pumping plant.

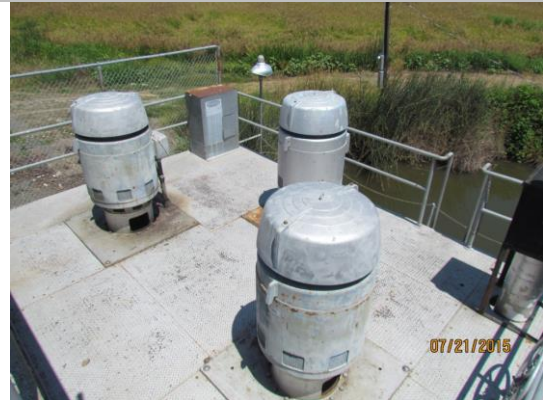
Photo 1 of 3 : ST_2015_NA0060_17_7_20150810_00022.jpg

LM Start	0.00	Rating **	A	Issue No.	7
LM End	0.00	Issue Type +	Ma	Location *	
Category	Pump Stations			GPS Latitude/Longitude	
				Start	End
Item	Pumps			39.142300 °	39.142300 °
				-122.902350 °	-122.902350 °
DWR ID	DWR_NA0060_17_t_2012_7				
Action/Comments					
Inspector Comments: The pumps appeared to be in good working condition and properly maintained including proper lubrication level.

View of the pumps.

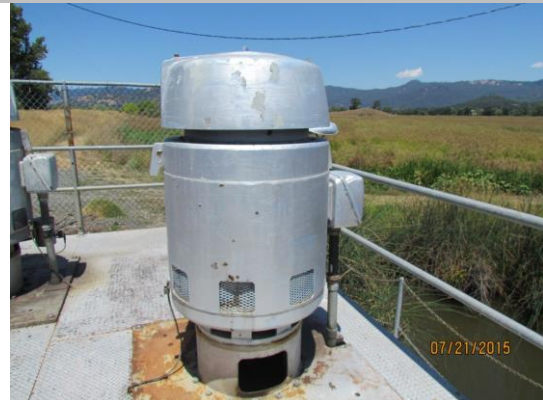
Photo 2 of 3 : ST_2015_NA0060_17_7_20150810_00023.jpg

View of one of the pumps.

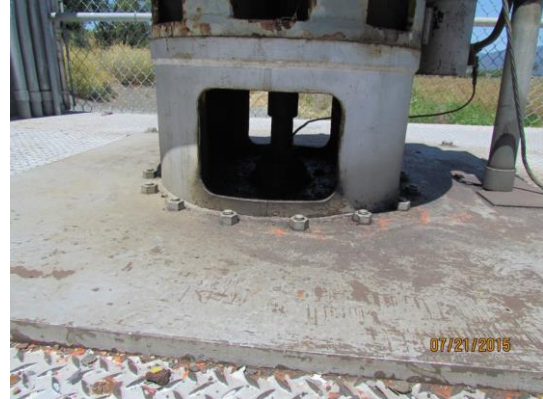
Photo 3 of 3 : ST_2015_NA0060_17_7_20150810_00024.jpg

LM Start	0.00	Rating **	A	Issue No.	7 (cont)
LM End	0.00	Issue Type +	Ma	Location *	
Category	Pump Stations			GPS Latitude/Longitude	
				Start	End
Item	Pumps			39.142300 °	39.142300 °
				-122.902350 °	-122.902350 °
DWR ID	DWR_NA0060_17_t_2012_7				
Action/Comments					
Inspector Comments: The pumps appeared to be in good working condition and properly maintained including proper lubrication level.

View of bottom of a pump.

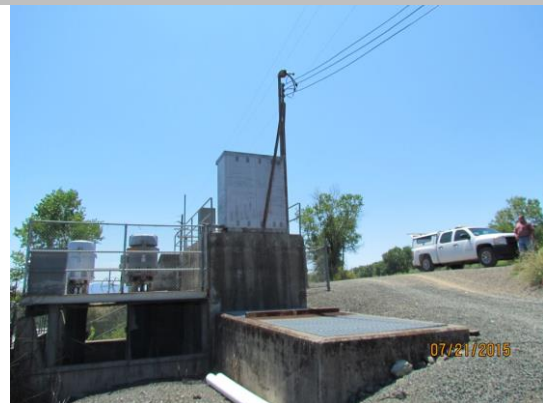
Photo 1 of 1 : ST_2015_NA0060_17_8_20150810_00025.jpg

LM Start	0.00	Rating **	A	Issue No.	8
LM End	0.00	Issue Type +	Ma	Location *	
Category	Pump Stations			GPS Latitude/Longitude	
				Start	End
Item	Power			39.142300 °	39.142300 °
				-122.902350 °	-122.902350 °
DWR ID	DWR_NA0060_17_t_2012_8				
Action/Comments					
Inspector Comments: The power source appeared to be reliable and safe.

View of the power source of the plant.

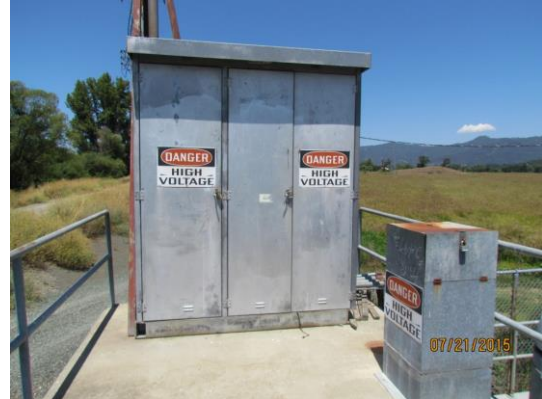
Photo 1 of 1 : ST_2015_NA0060_17_11_20150810_00026.jpg

LM Start	0.00	Rating **	A	Issue No.	11
LM End	0.00	Issue Type +	Ma	Location *	
Category	Pump Stations	GPS Latitude/Longitude			
		Start	End		
Item	Pump Control Systems	39.142300 °	39.142300 °		
		-122.902350 °	-122.902350 °		
DWR ID	DWR_NA0060_17_t_2012_11				
Action/Comments					
Inspector Comments: The pump control systems appeared to be operational and free of damage.

View of the pump control systems.

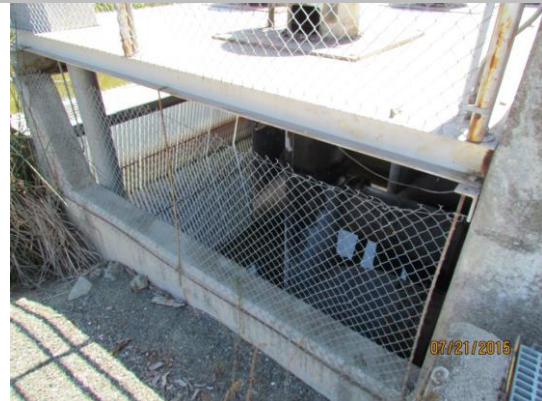
Photo 1 of 1 : ST_2015_NA0060_17_12_20150810_00033.jpg

LM Start	0.00	Rating **	A	Issue No.	12
LM End	0.00	Issue Type +	Ma	Location *	
Category	Pump Stations			GPS Latitude/Longitude	
				Start	End
Item	Sumps/Wet Well			39.142300 °	39.142300 °
				-122.902350 °	-122.902350 °
DWR ID	DWR_NA0060_17_t_2013_12				
Action/Comments					
Inspector Comments: Wet wells were clear of debris.

View of the wet well.

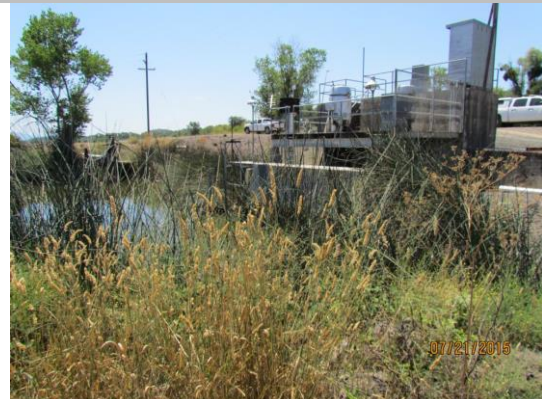
Photo 1 of 1 : ST_2015_NA0060_17_13_20150810_00028.jpg

LM Start	0.00	Rating **	A	Issue No.	13
LM End	0.00	Issue Type +	Ma	Location *	
Category	Pump Stations			GPS Latitude/Longitude	
				Start	End
Item	Trash Racks			39.142300 °	39.142300 °
				-122.902350 °	-122.902350 °
DWR ID	DWR_NA0060_17_t_2012_13				
Action/Comments					
Inspector Comments: Trash racks appeared to be in good condition and free of debris.

View of the trash racks.

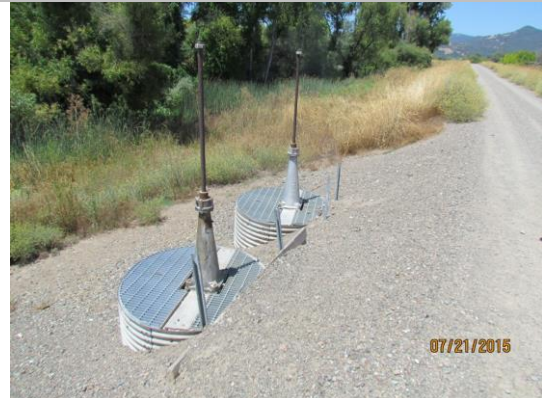
Photo 1 of 1 : ST_2015_NA0060_17_15_20150810_00029.jpg

LM Start	0.00	Rating **	A	Issue No.	15
LM End	0.00	Issue Type +	Ma	Location *	
Category	Pump Stations			GPS Latitude/Longitude	
				Start	End
Item	Sluice / Slide Gates			39.142300 °	39.142300 °
				-122.902350 °	-122.902350 °
DWR ID	DWR_NA0060_17_t_2013_15				
Action/Comments					
Inspector Comments: The slide gates appeared to be in a good working condition.

View of the slide gates.

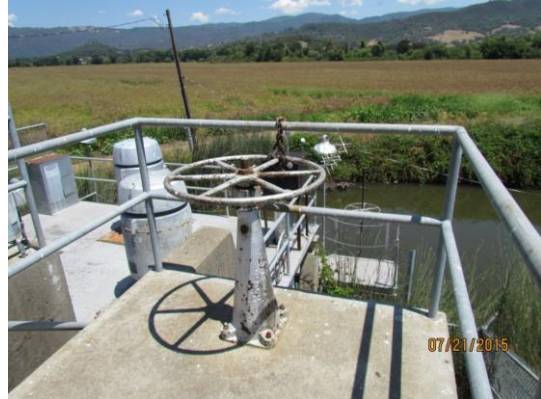
Photo 1 of 2 : ST_2015_NA0060_17_17_20150810_00030.jpg

LM Start	0.00	Rating **	A	Issue No.	17
LM End	0.00	Issue Type +	Ma	Location *	
Category	Pump Stations			GPS Latitude/Longitude	
				Start	End
Item	Manual Gate Operators			39.142300 °	39.142300 °
				-122.902350 °	-122.902350 °
DWR ID	DWR_NA0060_17_t_2012_17				
Action/Comments					
Inspector Comments: The manual gate operators appeared to be in good working condition.

View of one of the manual operators at the plant.

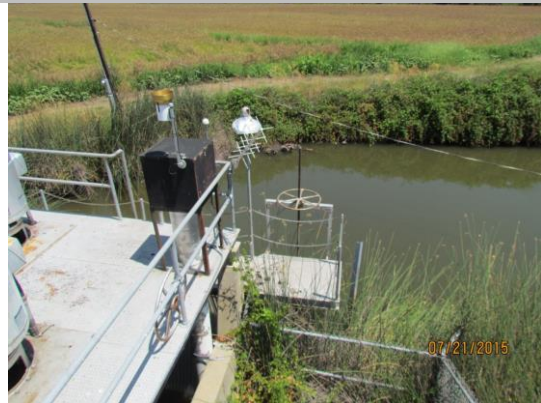
Photo 2 of 2 : ST_2015_NA0060_17_17_20150810_00031.jpg

View of another manual gate operator at the plant.

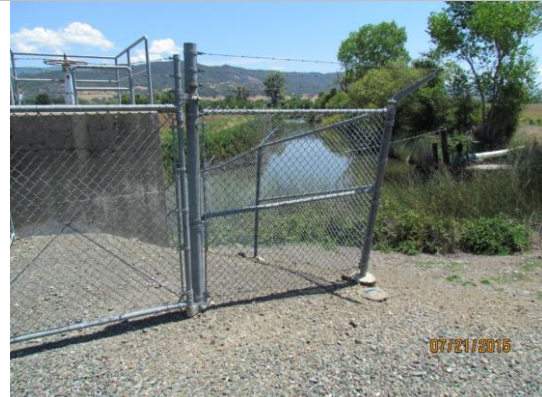
Photo 1 of 1 : ST_2015_NA0060_17_21_20150810_00032.jpg

LM Start	0.00	Rating **	A	Issue No.	21
LM End	0.00	Issue Type +	Ma	Location *	
Category	Pump Stations			GPS Latitude/Longitude	
				Start	End
Item	Security Fencing			39.142300 °	39.142300 °
				-122.902350 °	-122.902350 °
DWR ID	DWR_NA0060_17_t_2012_21				
Action/Comments					
Inspector Comments: Security fencing appeared to be in good condition.

View of the security fencing around the plant.

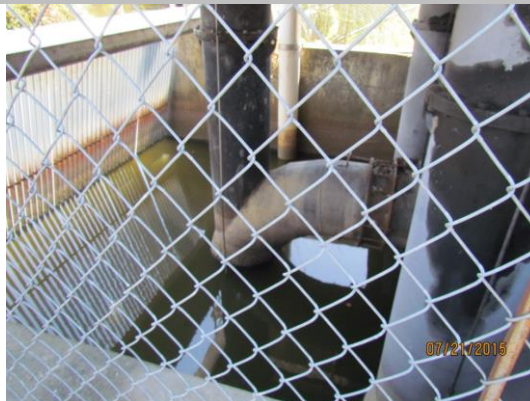
Photo 1 of 1 : ST_2015_NA0060_17_22_20150810_00034.jpg

LM Start	0.00	Rating **	A	Issue No.	22
LM End	0.00	Issue Type +	Ma	Location *	
Category	Pump Stations			GPS Latitude/Longitude	
				Start	End
Item	Intake and Discharge Pipes			39.142300 °	39.142300 °
				-122.902350 °	-122.902350 °
DWR ID	DWR_NA0060_17_t_2012_22				
Action/Comments					
Inspector Comments: The pipes appeared to be in good working condition.

View of the intake pipes.

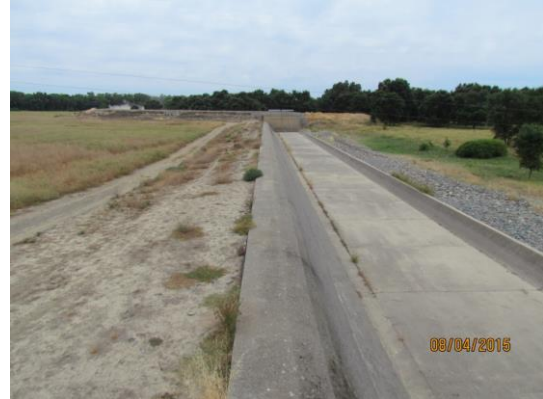
Photo 1 of 4 : ST_2015_NA0060_4_1_20150810_00005.jpg

View of the weir facing the left bank from the upstream side of the structure.

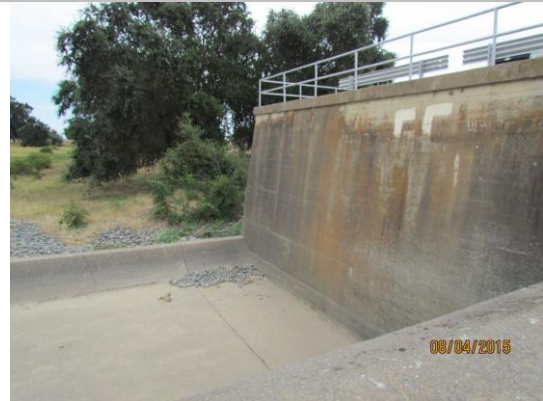
Photo 2 of 4 : ST_2015_NA0060_4_1_20150810_00006.jpg

View of the right bank of the weir facing downstream.

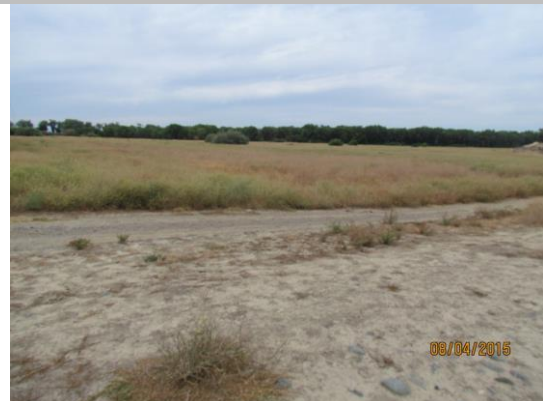
Photo 3 of 4 : ST_2015_NA0060_4_1_20150810_00007.jpg

Upstream view from the weir.

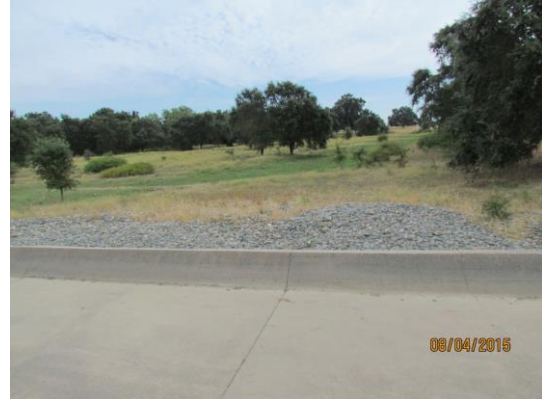
Photo 4 of 4 : ST_2015_NA0060_4_1_20150810_00008.jpg

Downstream view from the weir.

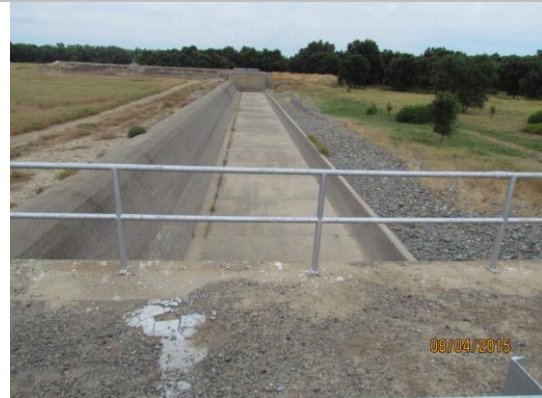
Photo 1 of 1 : x_2015_NA0060_4_23_20150820_00009.jpg

LM Start	0.00	Rating **	A	Issue No.	23
LM End	0.00	Issue Type +	Ma	Location *	
Category	Structures & Concrete Lined Channels			GPS Latitude/Longitude	
				Start	End
Item	Safety			39.338242 °	39.338242 °
				-122.022073 °	-122.022073 °
DWR ID	DWR_NA0060_4_t_2012_23				
Action/Comments					
Inspector Comments: Safety hardware installed. Adequate protection for fall hazards exist. No hazardous conditions that might affect the operation of the structure exist.

View of the safety railing installed on the weir.

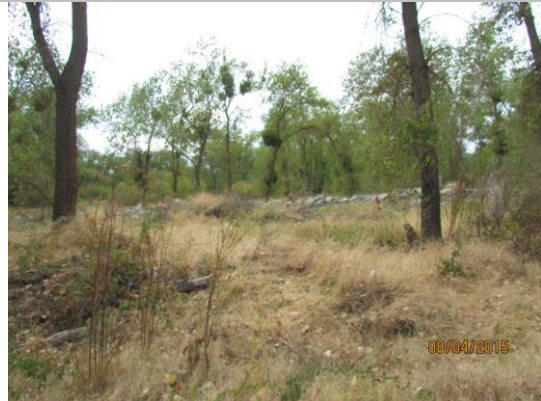
Photo 1 of 3 : ST_2015_NA0060_54_1_20150810_00004.jpg

View of the weir facing upstream.

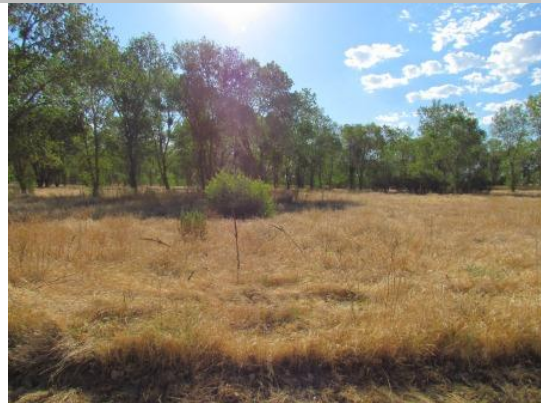
Photo 2 of 3 : ST_2015_NA0060_54_1_20150528_00002.jpg

This photo was taken looking downstream from the weir.

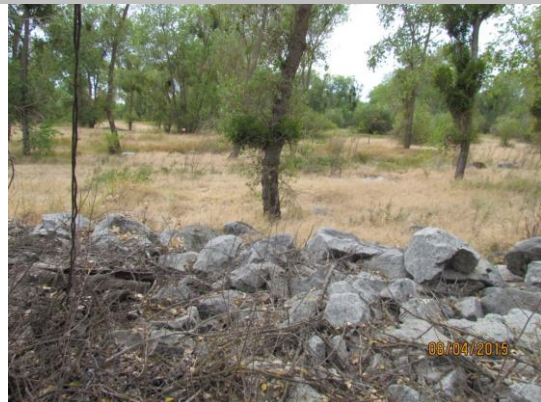
Photo 3 of 3 : ST_2015_NA0060_54_1_20150810_00007.jpg

View of the upstream side of the weir.

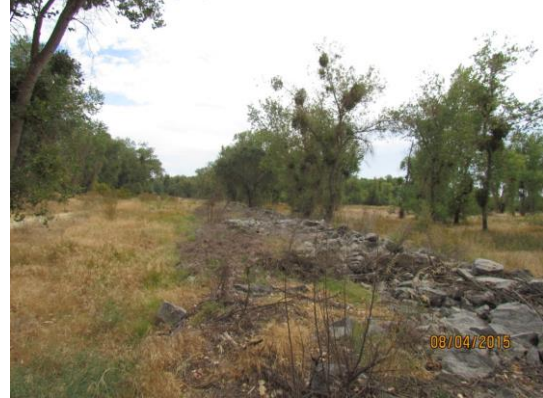
Photo 1 of 2 : x_2015_NA0060_54_2_20150820_00008.jpg

LM Start	0.00	Rating **	M	Issue No.	2
LM End	0.00	Issue Type +	Ma	Location *	
Category	Structures & Concrete Lined Channels			GPS Latitude/Longitude	
				Start	End
Item	Vegetation & Obstructions			38.895500 °	38.887450 °
				-121.616950 °	-121.615330 °
DWR ID	DWR_NA0060_54_t_2012_2				
Action/Comments					
Inspector Comments: Minimal, scattered obstructions or vegetation. The vegetation should be cleared and trees trimmed up. May impede flow in a high water event.

View of the obstructions facing the right bank.

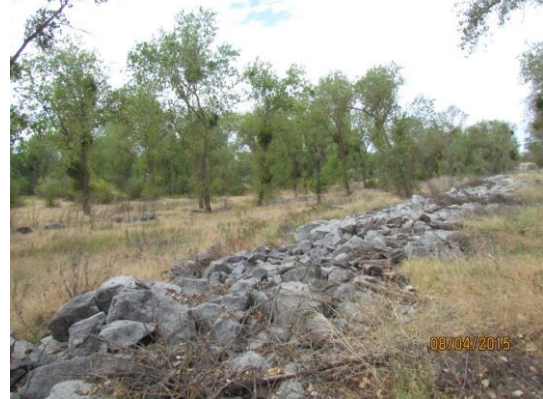
Photo 2 of 2 : x_2015_NA0060_54_2_20150820_00009.jpg

View of the obstructions facing the left bank.

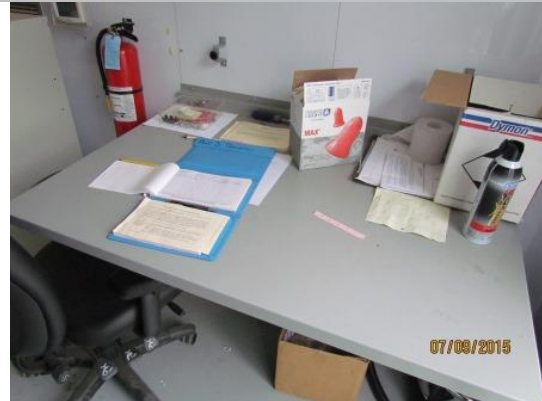
Photo 1 of 1 : ST_2015_NA0060_21_1_20150717_00014.jpg

LM Start	0.00	Rating **	A	Issue No.	1
LM End	0.00	Issue Type +	Ma	Location *	
Category	Pump Stations			GPS Latitude/Longitude	
				Start	End
Item	Operating Log			38.931815 °	38.931815 °
				-121.634331 °	-121.634331 °
DWR ID	DWR_NA0060_21_t_2012_1				
Action/Comments					
Inspector Comments: The operating log is kept on site.

View of the operating log.

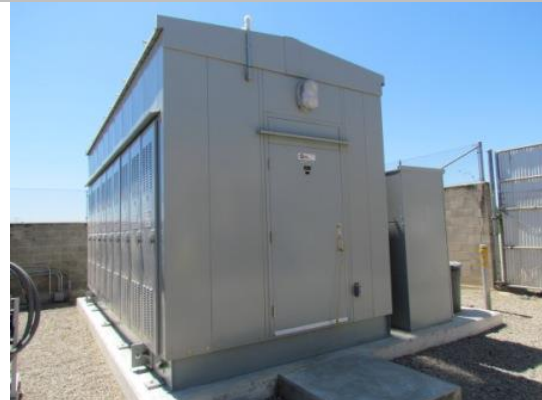
Photo 1 of 1 : ST_2015_NA0060_21_3_20150709_00002.jpg

LM Start	0.00	Rating **	A	Issue No.	3
LM End	0.00	Issue Type +	Ma	Location *	
Category	Pump Stations			GPS Latitude/Longitude	
				Start	End
Item	Plant Building			38.931815 °	38.931815 °
				-121.634331 °	-121.634331 °
DWR ID	DWR_NA0060_21_t_2012_3				
Action/Comments					
Inspector Comments: Plant building is mostly complete and appears to be in good working order. The project is currently under construction.

View of plant building under construction.

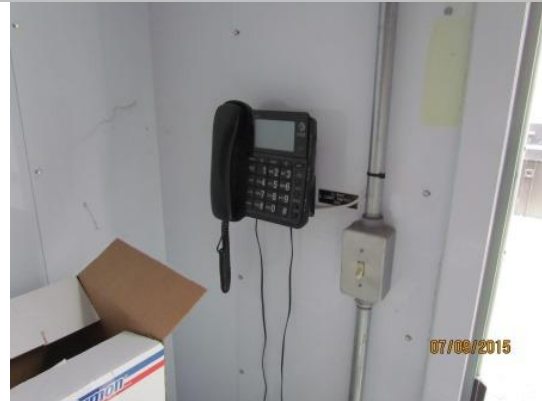
Photo 1 of 1 : ST_2015_NA0060_21_4_20150717_00015.jpg

LM Start	0.00	Rating **	A	Issue No.	4
LM End	0.00	Issue Type +	Ma	Location *	
Category	Pump Stations			GPS Latitude/Longitude	
				Start	End
Item	Communications			38.931815 °	38.931815 °
				-121.634331 °	-121.634331 °
DWR ID	DWR_NA0060_21_t_2012_4				
Action/Comments					
Inspector Comments: Cell phones and two-way radios are available to pump station operators. The remote control operatin system (SCADA) is currently being tested and should be ready by the start of flood season.

View of the telephone in the operating room.

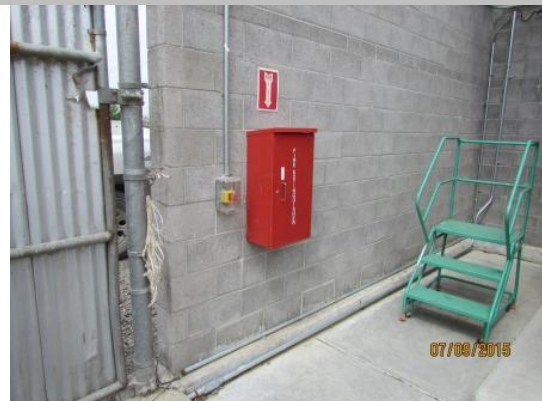
Photo 1 of 2 : ST_2015_NA0060_21_5_20150717_00016.jpg

LM Start	0.00	Rating **	M	Issue No.	5
LM End	0.00	Issue Type +	Ma	Location *	
Category	Pump Stations			GPS Latitude/Longitude	
				Start	End
Item	Safety			38.931815 °	38.931815 °
				-121.634331 °	-121.634331 °
DWR ID	DWR_NA0060_21_t_2012_5				
Action/Comments					
Inspector Comments: Site is under construction safety wear is required during construction (hard hat, vest and eyewear). There is missing safety railing above the inlet grates on the LS.

View of the fire extinguisher and emergency shutoff switch.

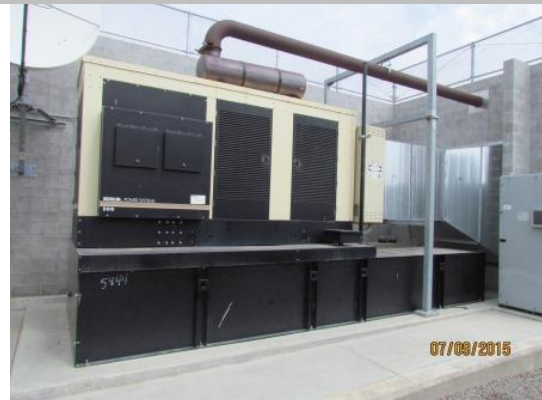
Photo 1 of 1 : ST_2015_NA0060_21_8_20150717_00017.jpg

LM Start	0.00	Rating **	A	Issue No.	8
LM End	0.00	Issue Type +	Ma	Location *	
Category	Pump Stations			GPS Latitude/Longitude	
				Start	End
Item	Power			38.931815 °	38.931815 °
				-121.634331 °	-121.634331 °
DWR ID	DWR_NA0060_21_t_2012_8				
Action/Comments					
Inspector Comments: The structure is on the grid with emergency backup generator.

View of the emergency backup generator.

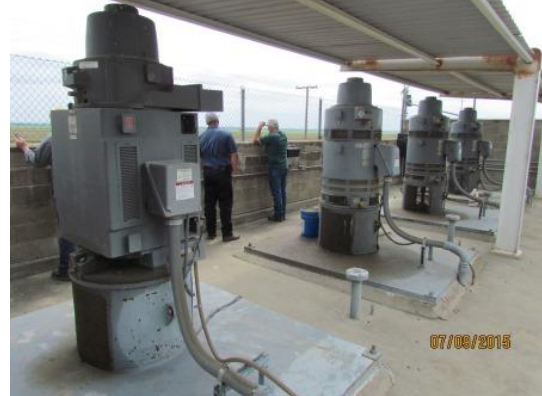
Photo 1 of 1 : ST_2015_NA0060_21_10_20150717_00018.jpg

LM Start	0.00	Rating **	A	Issue No.	10
LM End	0.00	Issue Type +	Ma	Location *	
Category	Pump Stations			GPS Latitude/Longitude	
				Start	End
Item	Motors, Engines, Fans & Gear Reducers			38.931815 °	38.931815 °
				-121.634331 °	-121.634331 °
DWR ID	DWR_NA0060_21_t_2012_10				
Action/Comments					
Inspector Comments: These items appear to be maintained and in operating condition.

Photo shows pump motors, which appear to be in operating condition.

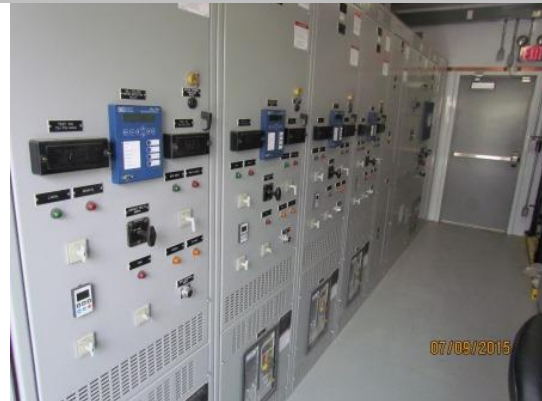
Photo 1 of 2 : ST_2015_NA0060_21_11_20150717_00019.jpg

LM Start	0.00	Rating **	A	Issue No.	11
LM End	0.00	Issue Type +	Ma	Location *	
Category	Pump Stations			GPS Latitude/Longitude	
				Start	End
Item	Pump Control Systems			38.931815 °	38.931815 °
				-121.634331 °	-121.634331 °
DWR ID	DWR_NA0060_21_t_2012_11				
Action/Comments					
Inspector Comments: Pump control systems on site are new and appear to be in working order.

View of the control room.

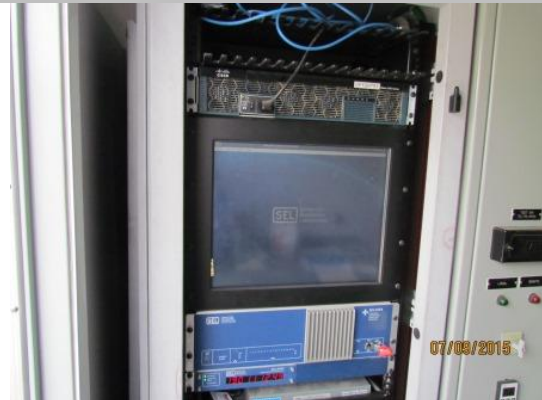
Photo 2 of 2 : ST_2015_NA0060_21_11_20150717_00020.jpg

View of the control computer.

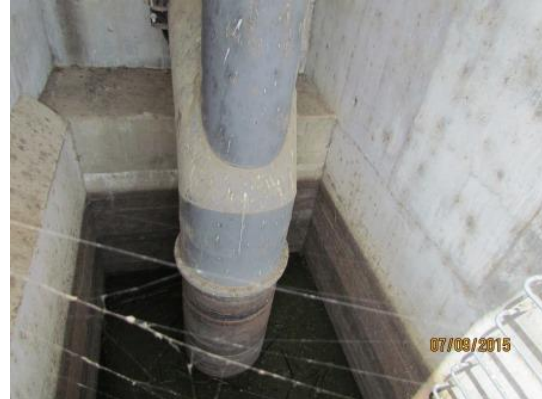
Photo 1 of 1 : ST_2015_NA0060_21_12_20150717_00021.jpg

LM Start	0.00	Rating **	A	Issue No.	12
LM End	0.00	Issue Type +	Ma	Location *	
Category	Pump Stations			GPS Latitude/Longitude	
				Start	End
Item	Sumps/Wet Well			38.931815 °	38.931815 °
				-121.634331 °	-121.634331 °
DWR ID	DWR_NA0060_21_t_2012_12				
Action/Comments					
Inspector Comments: Sumps are clear and free of debris.

View of the wet well.

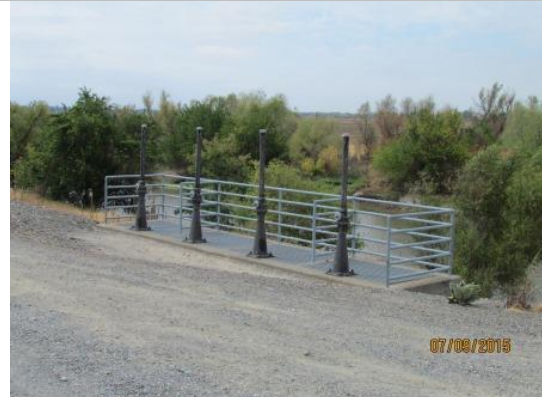
Photo 1 of 1 : ST_2015_NA0060_21_17_20150717_00024.jpg

LM Start	0.00	Rating **	A	Issue No.	17
LM End	0.00	Issue Type +	Ma	Location *	
Category	Pump Stations			GPS Latitude/Longitude	
				Start	End
Item	Manual Gate Operators			38.931815 °	38.931815 °
				-121.634331 °	-121.634331 °
DWR ID	DWR_NA0060_21_t_2012_17				
Action/Comments					
Inspector Comments: Manual gate operators appear to be in good working condition.

Photo shows sluice gate operators. Note: Operators can be operated either mechanically or manually.

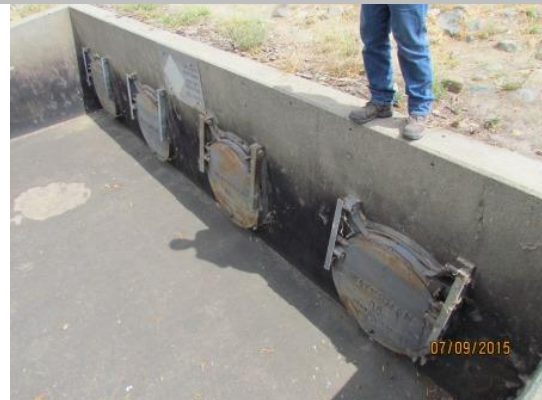
Photo 1 of 1 : ST_2015_NA0060_21_19_20150717_00025.jpg

LM Start	0.00	Rating **	A	Issue No.	19
LM End	0.00	Issue Type +	Ma	Location *	
Category	Pump Stations			GPS Latitude/Longitude	
				Start	End
Item	Flap Gates			38.931815 °	38.931815 °
				-121.634331 °	-121.634331 °
DWR ID	DWR_NA0060_21_t _ 2012_19				
Action/Comments					
Inspector Comments: Flap gates are in proper working condition, they show no signs of corrosion or damage.

Photo shows flap gates and concrete outfall structure.

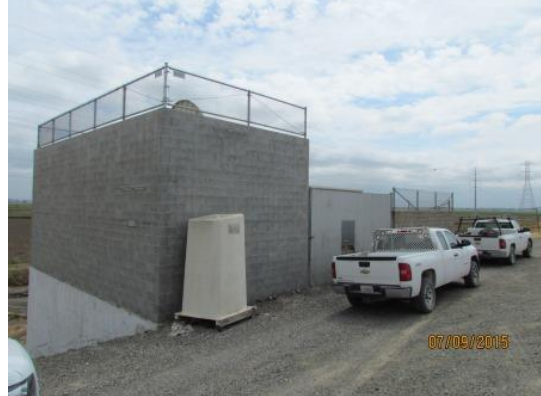
Photo 1 of 1 : ST_2015_NA0060_21_21_20150717_00026.jpg

LM Start	0.00	Rating **	A	Issue No.	21
LM End	0.00	Issue Type +	Ma	Location *	
Category	Pump Stations			GPS Latitude/Longitude	
				Start	End
Item	Security Fencing			38.931815 °	38.931815 °
				-121.634331 °	-121.634331 °
DWR ID	DWR_NA0060_21_t_2012_21				
Action/Comments					
Inspector Comments: Site is currently secured by a masonry brick wall.

Photo shows masonry brick wall which encloses the pump plant.

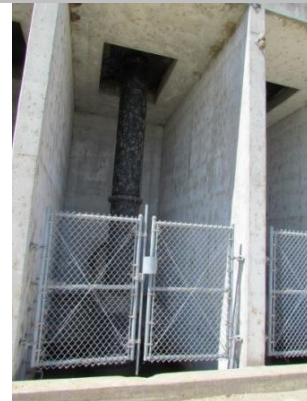
Photo 1 of 2 : ST_2015_NA0060_21_22_20150709_00013.jpg

LM Start	0.00	Rating **	A	Issue No.	22
LM End	0.00	Issue Type +	Ma	Location *	
Category	Pump Stations			GPS Latitude/Longitude	
				Start	End
Item	Intake and Discharge Pipes			38.931815 °	38.931815 °
				-121.634331 °	-121.634331 °
DWR ID	DWR_NA0060_21_t_2012_22				
Action/Comments					
Inspector Comments: No visible deficiencies observed in the pipe's condition.

Photo shows pump intake pipe, typical.

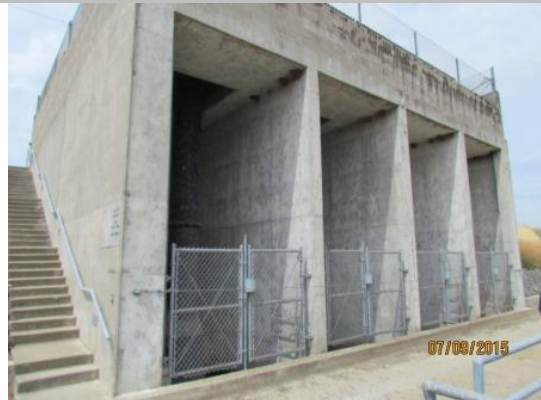
Photo 2 of 2 : ST_2015_NA0060_21_22_20150717_00027.jpg

View of the intake wells.

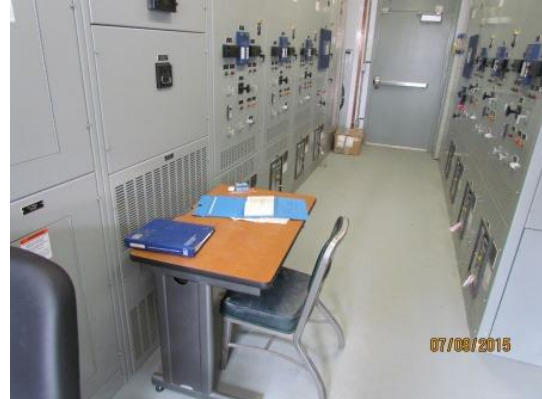
Photo 1 of 1 : ST_2015_NA0060_22_1_20150720_00015.jpg

LM Start	0.00	Rating **	A	Issue No.	1
LM End	0.00	Issue Type +	Ma	Location *	
Category	Pump Stations			GPS Latitude/Longitude	
				Start	End
Item	Operating Log			39.026449 °	39.026449 °
				-121.726937 °	-121.726937 °
DWR ID	DWR_NA0060_22_t_2012_1				
Action/Comments					
Inspector Comments: Operation log is located at the site.

View of the operating log.

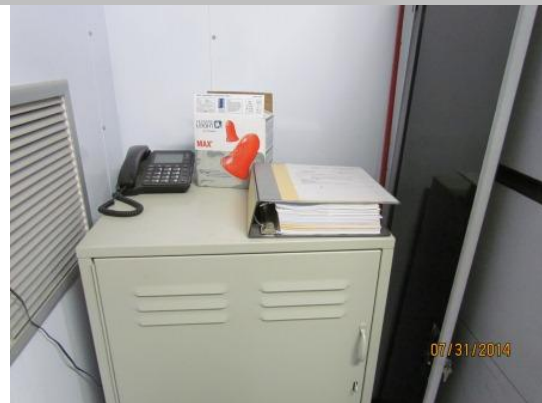
Photo 1 of 1 : ST_2015_NA0060_22_4_20150709_00003.jpg

LM Start	0.00	Rating **	A	Issue No.	4
LM End	0.00	Issue Type +	Ma	Location *	
Category	Pump Stations			GPS Latitude/Longitude	
				Start	End
Item	Communications			39.026449 °	39.026449 °
				-121.726937 °	-121.726937 °
DWR ID	DWR_NA0060_22_t_2012_4				
Action/Comments					
Inspector Comments: Operator has two-way radio and cellular phone available to them. The remote control system is currently being tested and should be ready by the start of flood season.

View of the on-site telephone.
